## CASE STUDY 1

### Infrared Thermography Case Study: Financial Data Center

Data collection January 25, 2008

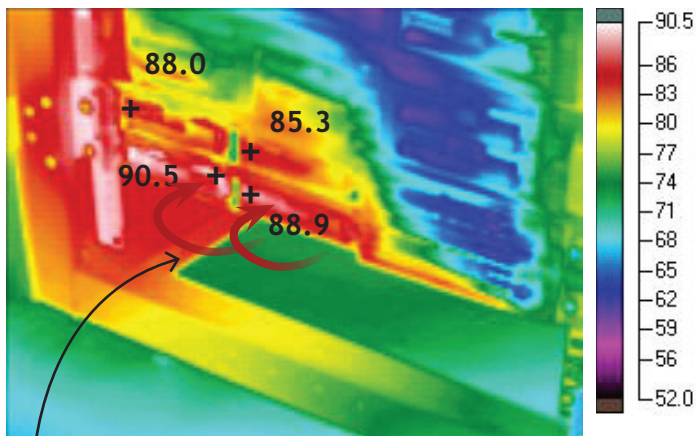
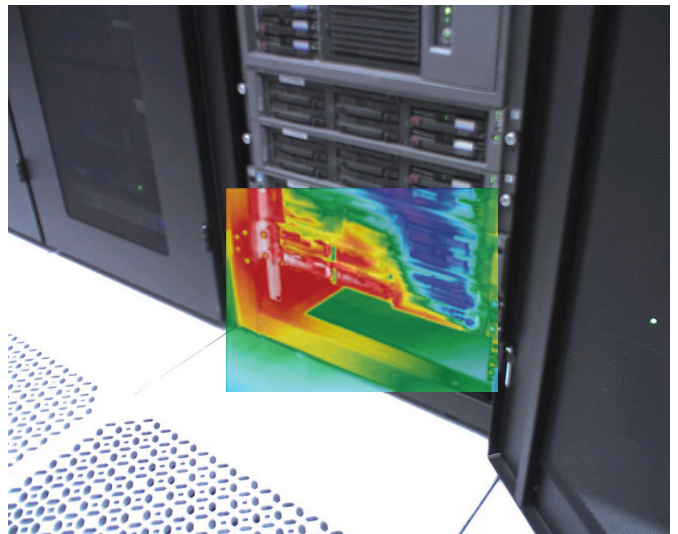
- The primary hot exhaust-air circulation pattern is under the lowest installed server, through the 2U opening.
- A secondary exhaust circulation pattern is around the sides of equipment, through the opening between the sides of the cabinet and rails.
- An insufficient volume of conditioned airflow is not the cause of the high air-intake temperatures.

Infrared image of cabinet base before installation of the 2U HotLok Blanking Panel

- Hot exhaust air recirculating under servers from the back of the cabinet enclosure

A 2U HotLok™ Blanking Panel was installed in the opening at the base of the cabinet in less than one minute. IT equipment air-intake temperatures were recorded five minutes after installation of the HotLok Blanking Panel.

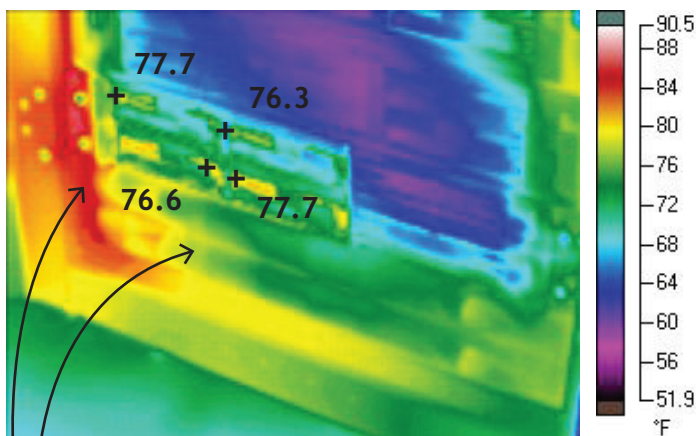
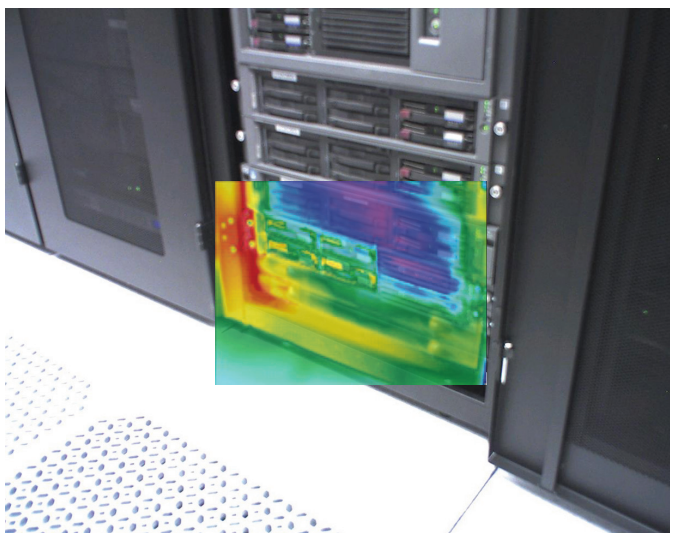
Five minutes after installation of the 2U HotLok Blanking Panel, the air-intake temperature of the four points measured in the server air-intake area dropped by an average of 11.4°F.

Infrared image of cabinet base five minutes after installation of the 2U HotLok Blanking Panel

- The installed 2U HotLok Blanking Panel has blocked the hot exhaust-air circulation, reducing air-intake temperatures significantly.
- Hot exhaust-air circulation remains around the sides of the servers. If the space between the rails and the side of the cabinet are sealed, the IT equipment air-intake temperatures will decrease further.
